BARON'S SOUTH PROPERTY  
GOLDEN SHADOWS RESIDENCE  
COMPO ROAD  
WESTPORT, CT

A REPORT PREPARED BY:  
Selectman's Maintenance Study Committee  
Town of Westport, Westport CT 06880

Report Dated: June 30, 2022

FIRST SELECTMAN'S MAINTENANCE STUDY COMMITTEE  
REPORT FOR THE BARON'S SOUTH PROPERTY, COMPO ROAD, WESTPORT, CT  
GOLDEN SHADOWS RESIDENCE  
INSPECTION: May 24, 2022  
RE-INSPECTION June 28, 2022  
DRAFT REPORT PREPARED: May 25, 2022  
FINAL REPORT PREPARED June 30, 2022

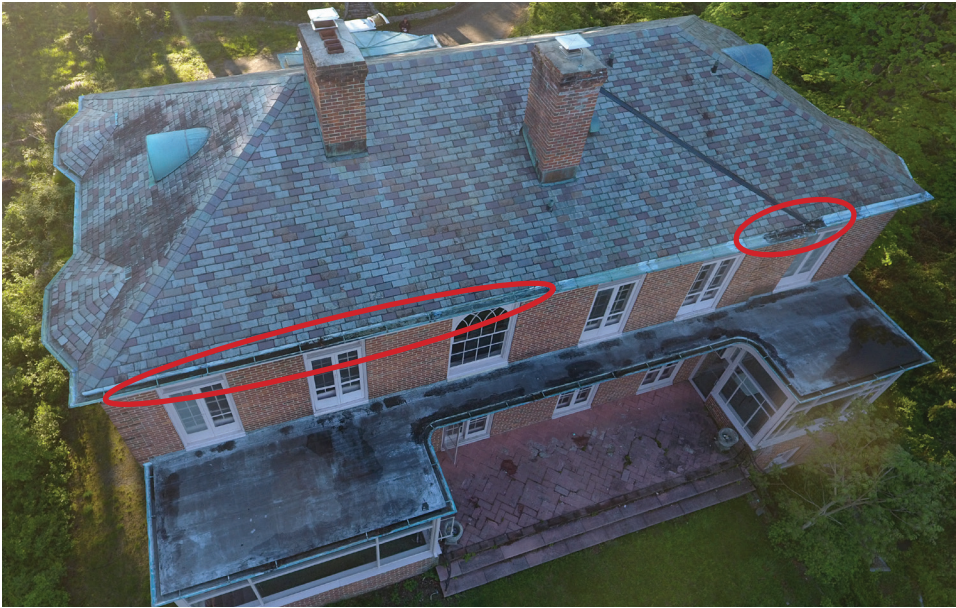
Gutters need cleaning in areas, some internal gutters broken, cause of leaks.

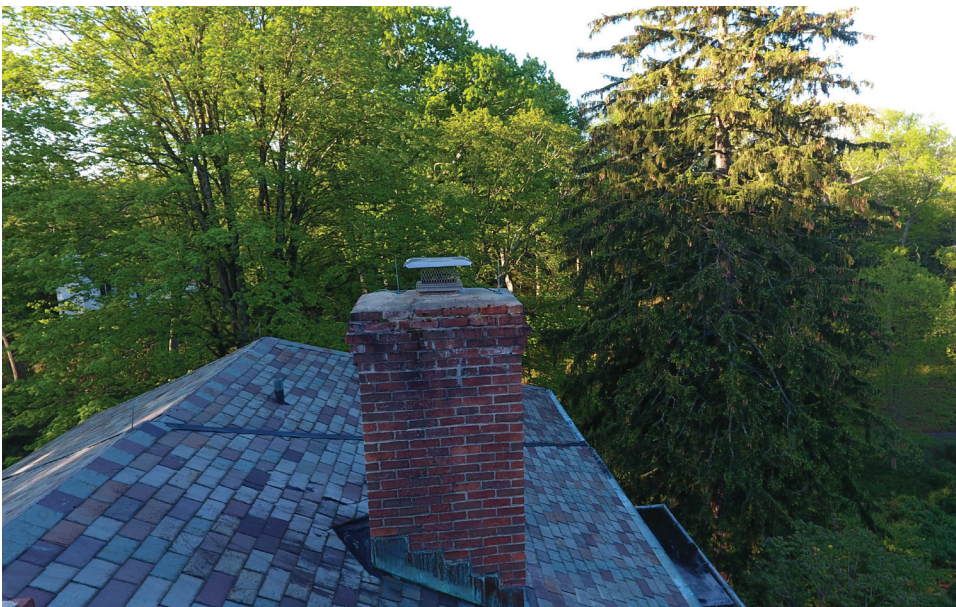
Chimney requires repointing.

3. The site and grounds are still somewhat overgrown, however, similar to last September and July 2019 thinning of trees close to the residence was accomplished. Now only one new dead pine tree is close to the residence, it should be removed.
4. Chimney repointing is warranted, drone photograph shows the extent.

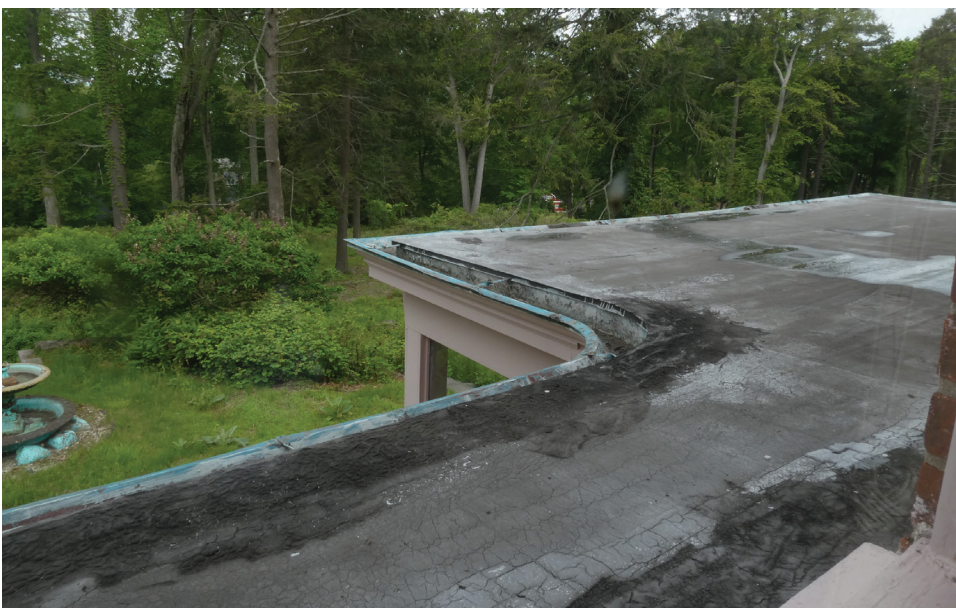
Flat roof area has very old built-up roof, some gutters leaking.

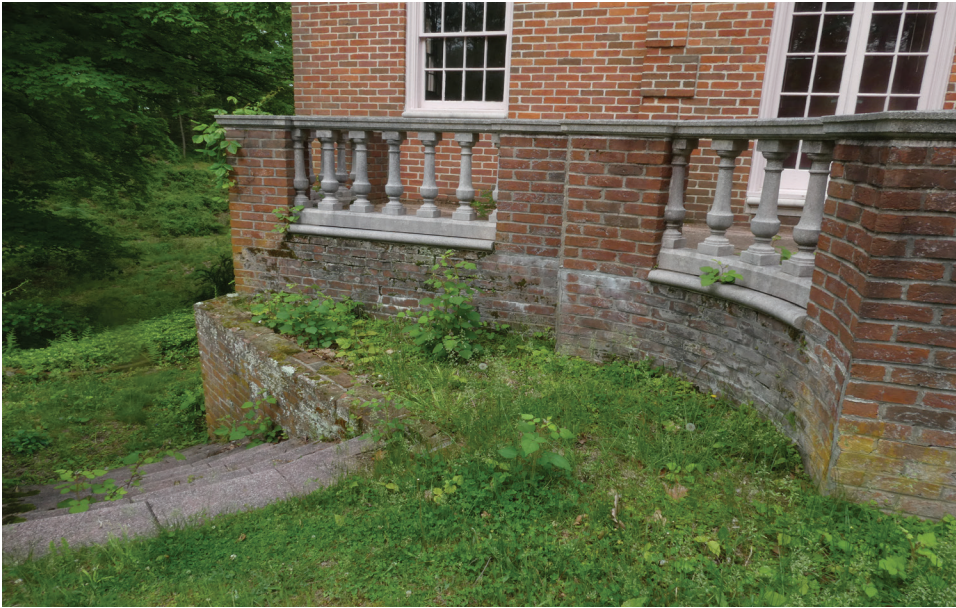
Front entry terrace wall needs rebuilding/  
repointing and balustrade work in areas.

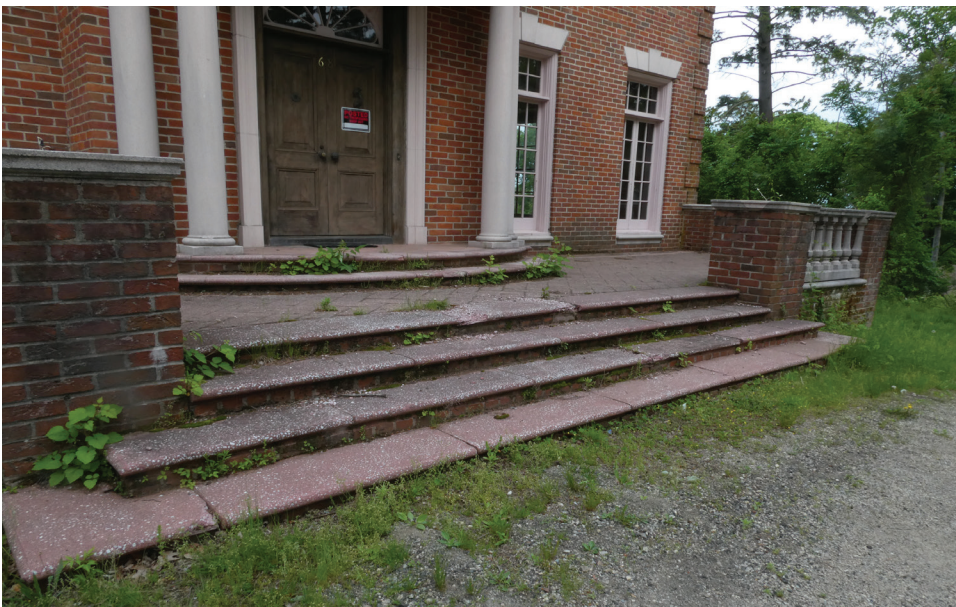
Front steps are spalling, some are out of place and the front stone patio is leaking, the area will soon be lost, meaning requiring full replacement vs. repair if not attended to shortly. Work on these items should start before next winters freeze/thaw cycles. The treads are now loose and some rock, this is now a liability issue along with exposed steel wire reinforcing fabric showing through the precast stair treads.

Front steps requires replacement.

5. Patio and stair treads and risers need restoration and replacement.
6. Crack repair and window lintel repair is required shortly along with waterproof coating. Accelerated deterioration is even more evident than 2019.
7. The patio and walls are deteriorating at an accelerated rate due to the lack of on-going maintenance, and open coping joints. Patio and walls need partial removal, resetting and cleaning. Sub-patio conditions are unknown.
8. Caulking is peeling and falling from joints, between brick and wood. Thus, failing at doors and windows.
9. More fascia boards now show signs of peeling paint and rotting in spots. See photos.

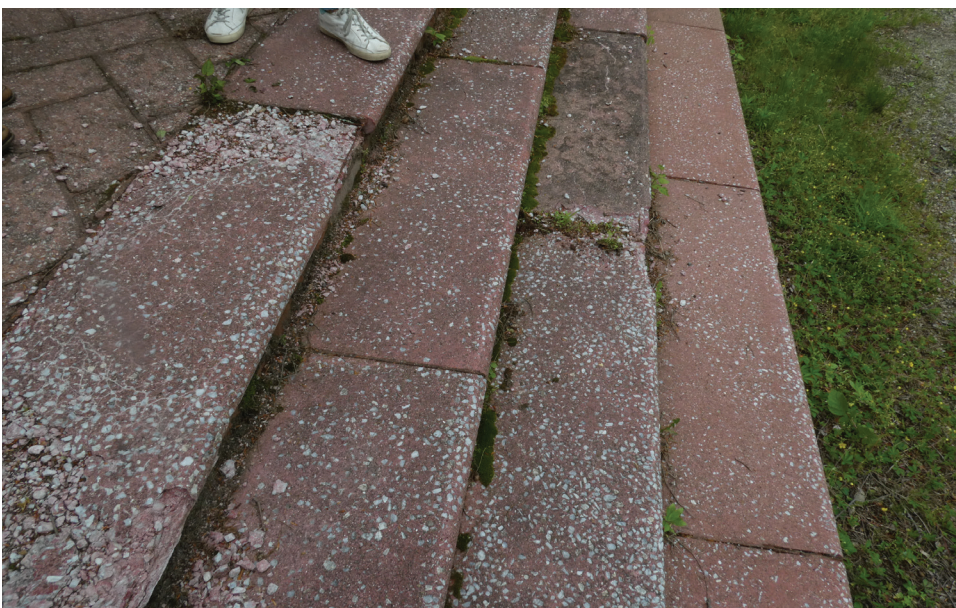
Rocking step treads and rebar at tread toe  
(potential tripping hazard)

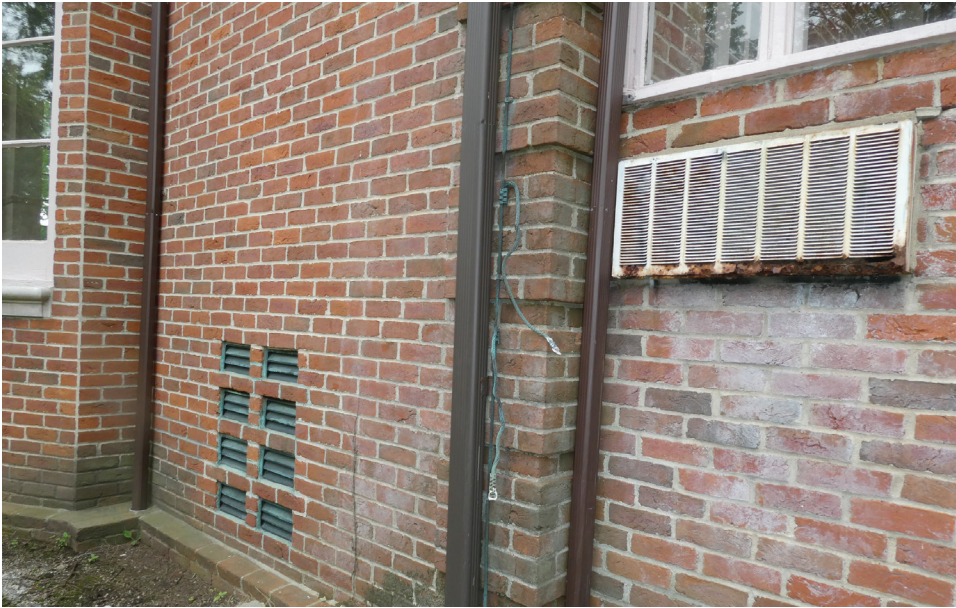
Leaking at top of A/C enclosure wall cracking.

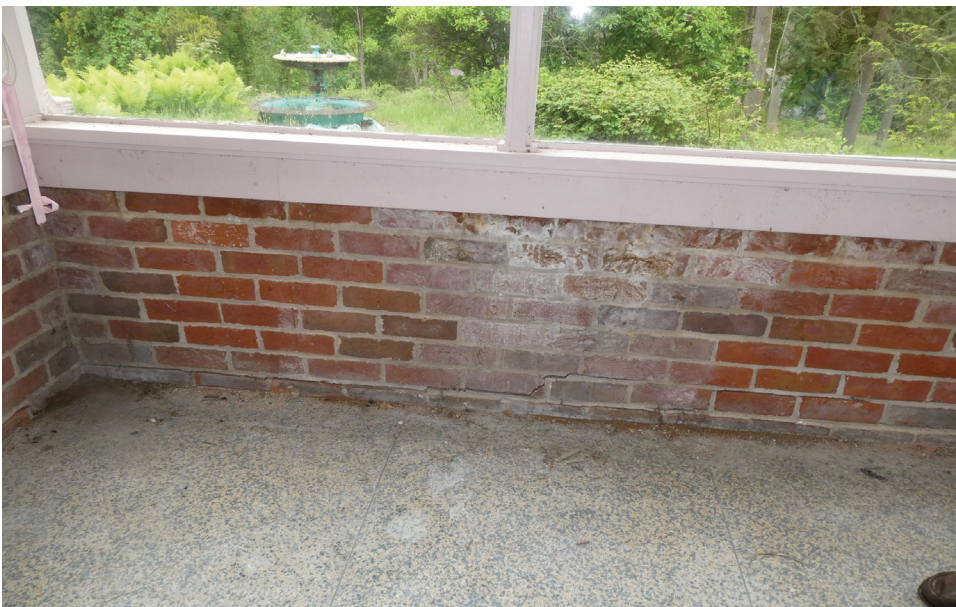
Terrace wall leaking, caulking needed.

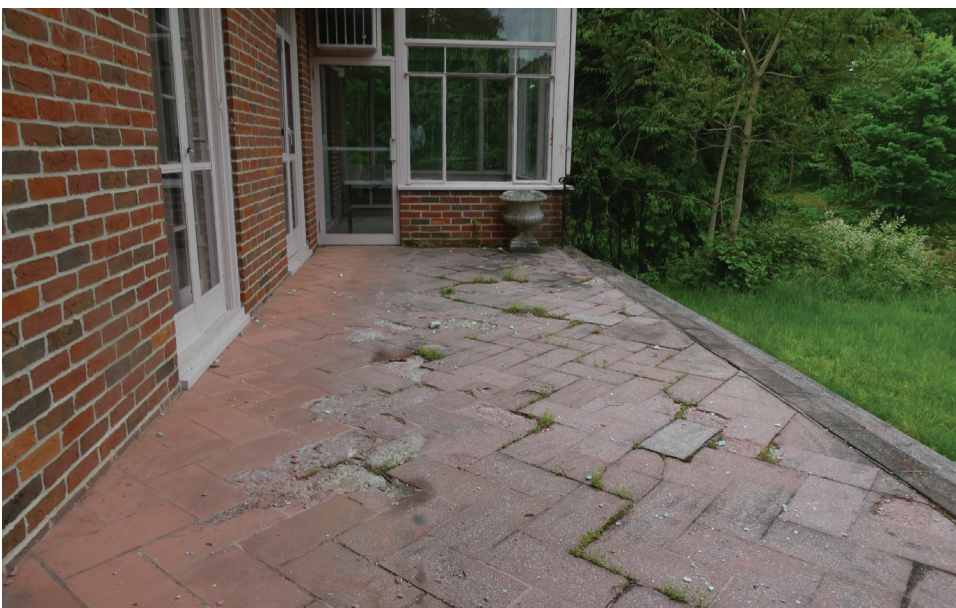
Rear terrace patio decaying quickly.

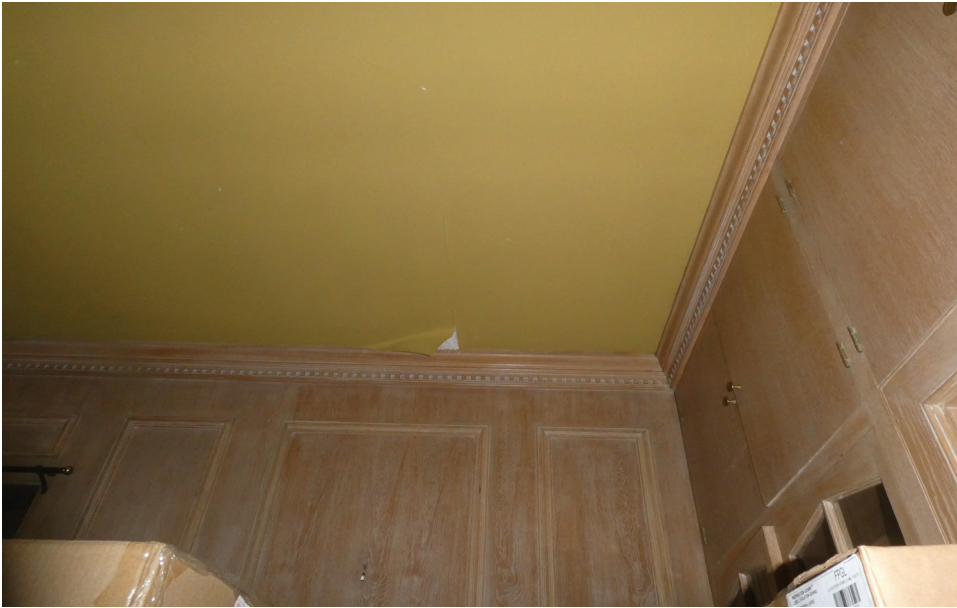
6. Some of the rooms (most) on the upper floor have some signs of small water intrusions, with stains on the wall paper/plaster at the ceiling to wall vaulted areas in spots along the outside wall.

Leaks extend at more and more areas around perimeter of rooms.

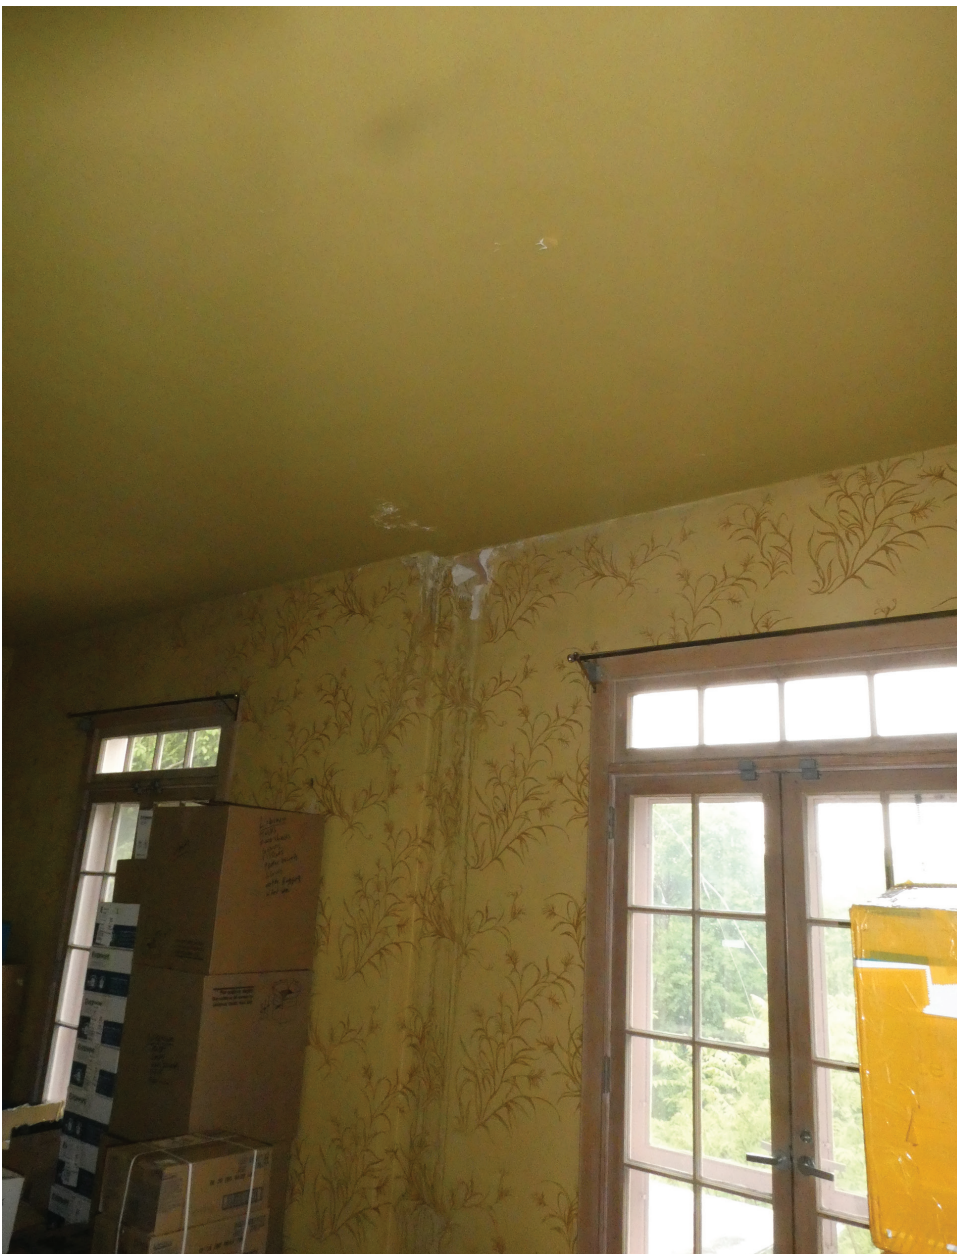
9. The second floor was reviewed including the bedroom, study and bathrooms. It appears that previous roof leaks under or near the building's exterior gutter system have been repaired. Some paint is spalled. The second floor SE side has a more major leak which continues to grow.

Bad leak at Southwest facade wall/roof jog.

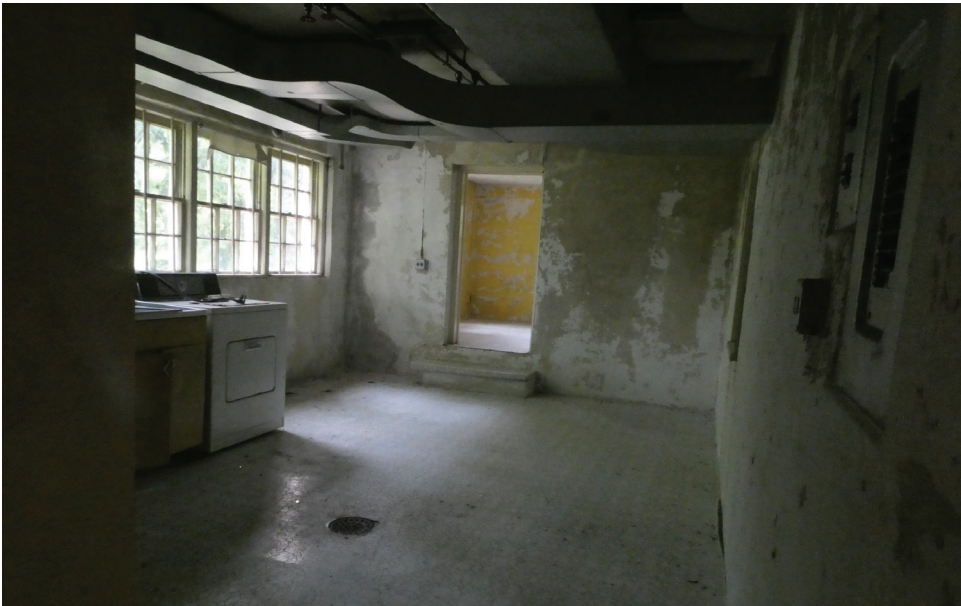
Basement Northwest room smell from mildew.

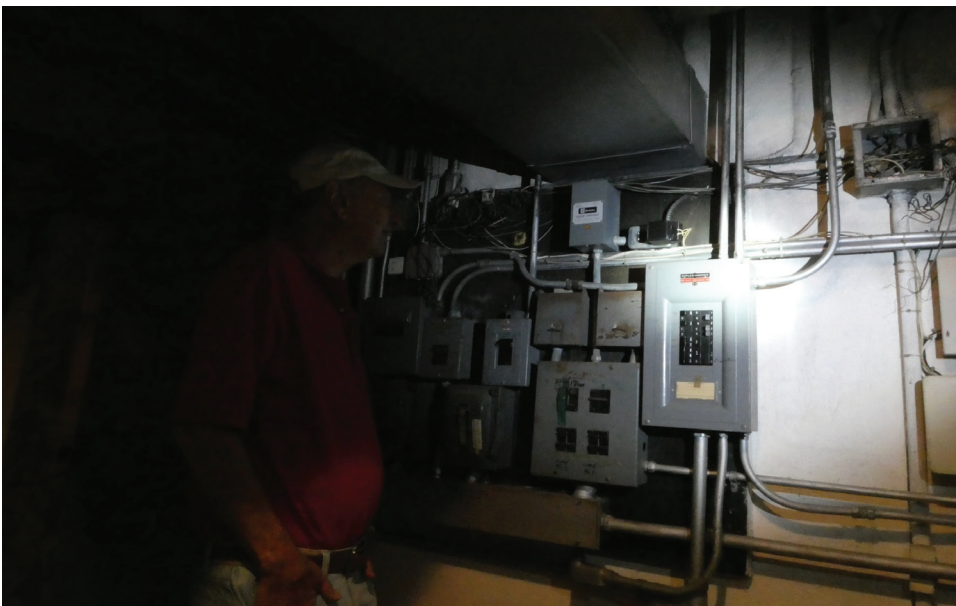
Electrical systems from various years, no apparent issues. one box unclcovered.

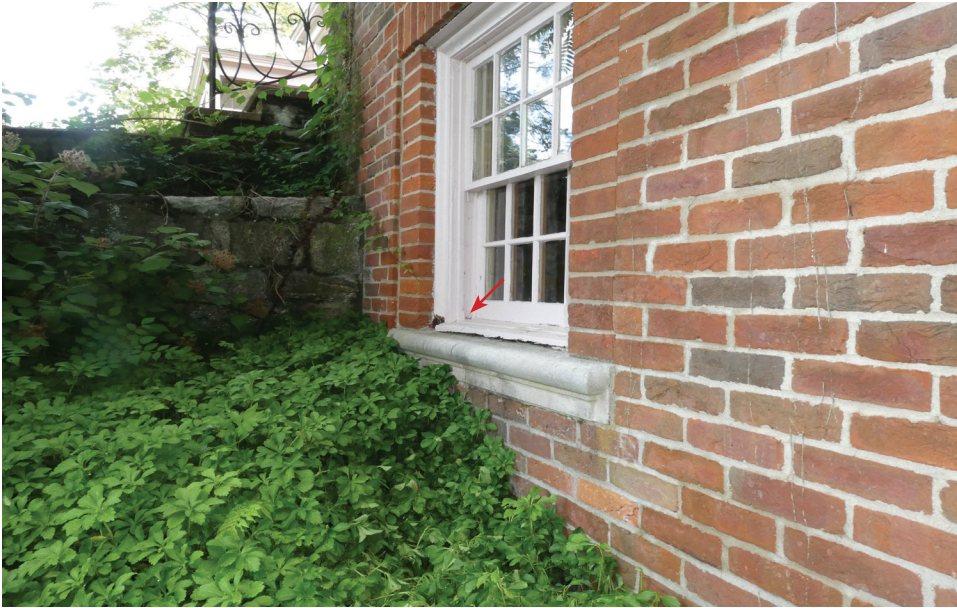
7. All of the wall woodwork appears in satisfactory shape along with the metal cabinetry in the kitchen. Ceiling paint is peeling, repairs are needed.
8. A few areas of water intrusion were noticed along the rotted windowsills and other such typical deterioration over the last twenty-three year span since the residence was fully resided in. More than a few areas of water intrusion are now easily observed. Many wood window frames are getting more rotted, they will be lost shortly. The lower floor sill to the SW is quite deteriorated. See photographs.

Rotted window sill

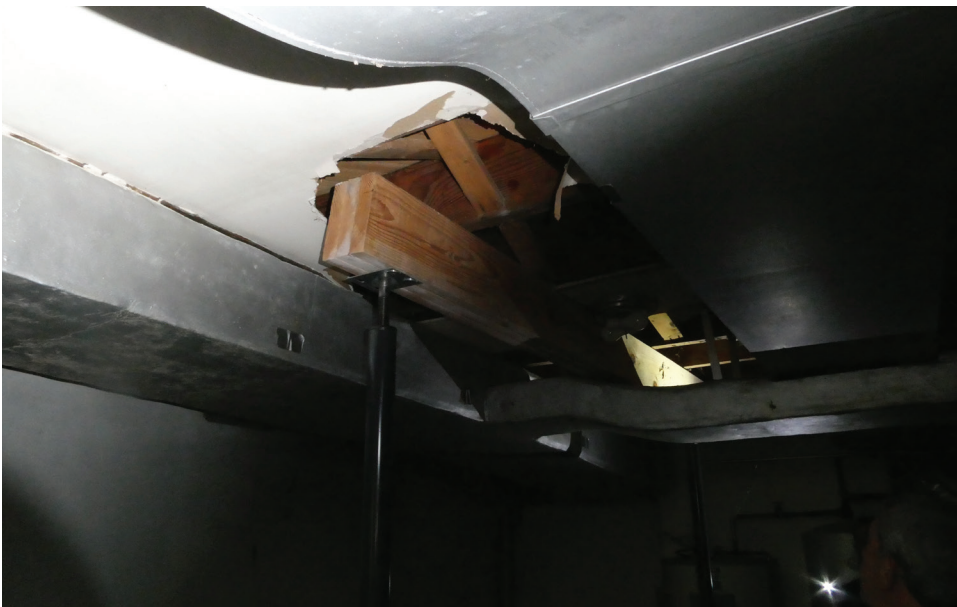
1. The structure has been previously used for storage of books by the Westport Public Library, has no occupancy and now has some light storage on all floors in many rooms, prudently distributing the light loads throughout the structure. The basement has temporary shoring (bracing) in one room, supporting approx., 8 floor joists, one of which is cracked and screwed together, over the shoring system. Observation of the foundation walls in this room do not show any cracks even with the required addition temporary shoring. A structural engineer should

Temporary shoring system in basement.

be engaged to further investigate and design permanent joist repair(s), and the ceiling patched. See photographs.

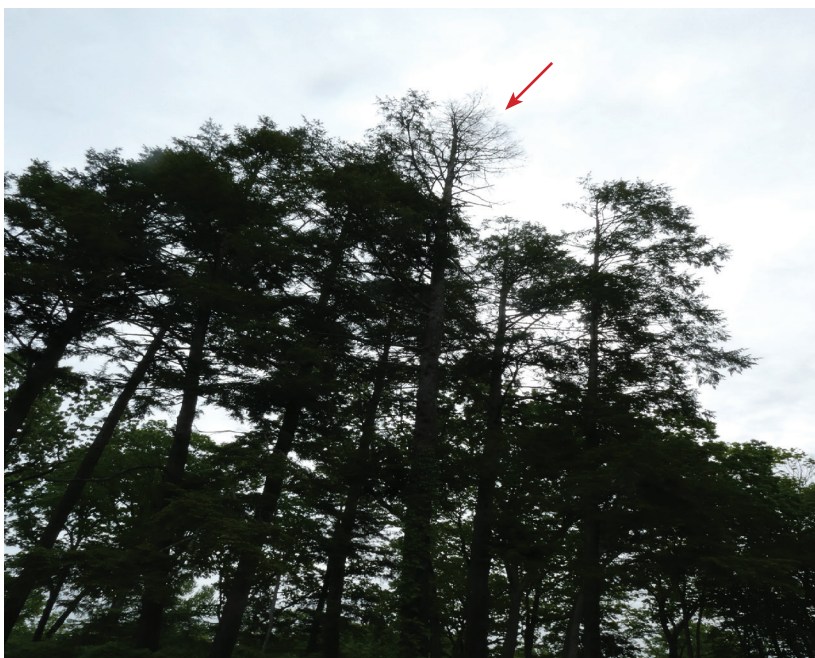
Dead pine trees should be removed.

3. One large dead pine tree requires removing on the east side of the building. Tree warden should be notified. See photograph.
